Milton Malsor Parish Council

Village Park Play Equipment Assessment form

Date of Assessment **26 Sept & 3 October 2011**

PLAY AREA SAFETY INSPECTION REPORT

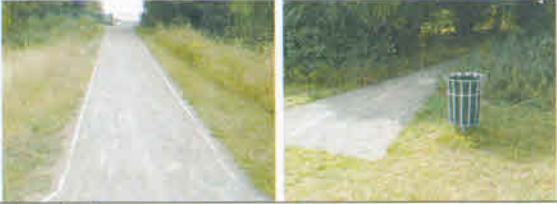
Item	Type	Comments, action or control required	Risk Level†	Risk Score‡
Access	Concrete Drive/Ramp	Good	L	
Pathway	Crushed Stone	Good

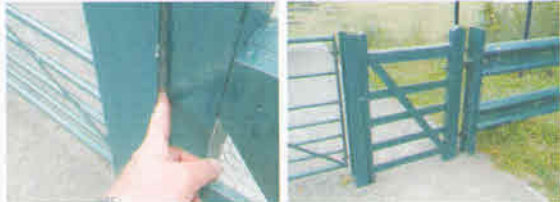
L	
	Wooden gate	Entrapment on side(s) of gate <i>Adjust gate/posts/fit new rubber buffer to ensure a spacing of at least 12 mm throughout the range of the gate to remove the entrapment. The 12 mm gap also should apply on the hinge side of the gate. Medium risk</i>

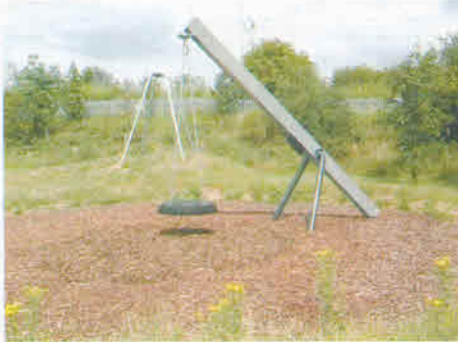
Swing Tyre Cantilever
Sutcliffe Leisure
Approximate Date: 2011

Comments, action or control required	Risk Level†	Risk Score‡
Equipment	This swing type has been associated with injury due to high spinning speeds when the chains are twisted together very tightly <i>It is recommended that the swing be checked on a routine basis to ensure that no unauthorised additions or alterations have been made to the chains, and that the bearing rotates freely, with appropriate remedial action taken where necessary.</i>	L/M	
Surfacing	No remedial maintenance work is required at this time		
The overall risk for the this item at the time of inspection:		L/M	
If work is completed the risk on this item can reduce to:		L	
† L = Low, LM = Low/medium, M = Medium, MH = Medium/high, H = High, U = Unacceptable			
‡ For scoring system see Report Notes

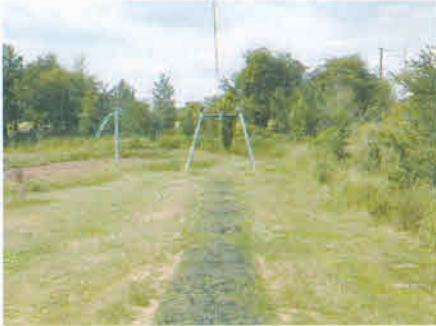
Cableway
 Sutcliffe Leisure
 Approximate Date: 2011

<p>Minimum ground clearance loaded 16st at centre point 400mm</p>	M	
Surfacing	No remedial maintenance work is required at this time		
The overall risk for the this item at the time of inspection:		M	
If work is completed the risk on this item can reduce to:		L	
<small>† L = Low, LM = Low/medium, M = Medium, MH = Medium/high, H = High, U = Unacceptable ‡ For scoring system see Report Notes</small>

SH COMMENTS: Ground clearance without load is slightly less than 400mm - can someone else please check. To discuss at park committee meeting

Comments, action or control required	Risk Level†	Risk Score‡
Equipment	<p><i>Adjust cable tension to raise seat</i></p>

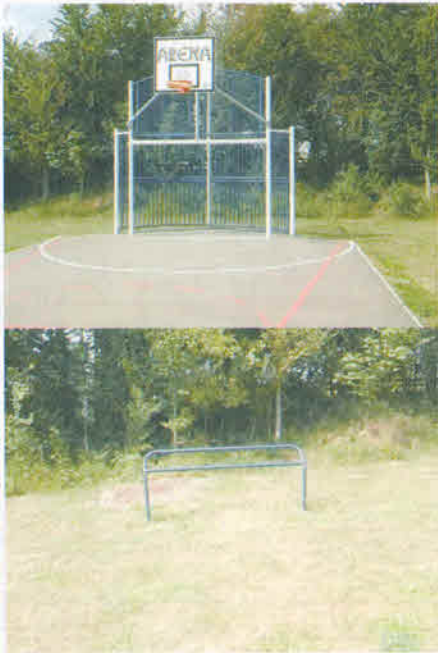
Games Wall & Seating

Comments, action or control required	Risk Level†	Risk Score‡
Equipment	No remedial maintenance work is required at this time		
Surfacing	Trip zones at edge of surface <i>Build up ground levels to remove trip hazard</i>  	M	
The overall risk for the this item at the time of inspection:		M	
If work is completed the risk on this item can reduce to:		L	
† L = Low, LM = Low/medium, M = Medium, MH = Medium/high, H = High, U = Unacceptable ‡ For scoring system see Report Notes

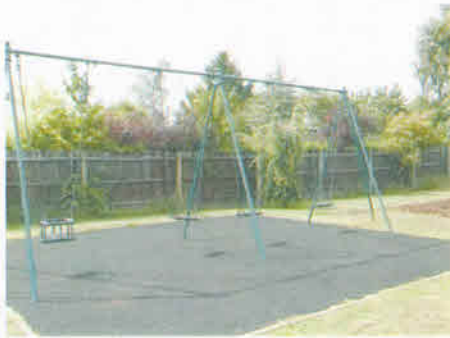
12 Bay – 1 Cradle – 3 Junior Swings
Wicksteed Leisure Limited

The item fails to meet the requirements of EN 1176 in the following respects:

The distance between the seat side and the support is insufficient

Comments, action or control required	Risk Level†	Risk Score‡
Equipment	The distance between the seat side and the support is insufficient

L	
	Loose swing seat eye-bolts <i>Tighten connecting nuts</i>

M	
	<i>Not recommended use of this type of shackle</i>

SH COMMENTS: Inspected these and it is fairly minor but needs to be tightened with a socket set - will attempt to do this with a socket set over the next week or so - to discuss at park committee meeting.

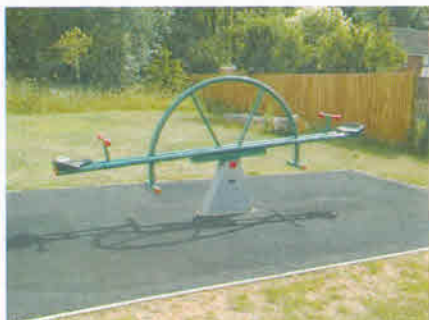
Seesaw
Sutcliffe Leisure
Approximate Date: 2011

Comments, action or control required	Risk Level†	Risk Score‡
Equipment	No remedial maintenance work is required at this time		
Surfacing	Trip zones at edge of surface <i>Build up ground levels to remove trip hazard</i>

M	
The overall risk for the this item at the time of inspection:		M	
If work is completed the risk on this item can reduce to:		L	
† L = Low, LM = Low/medium, M = Medium, MH = Medium/high, H = High, U = Unacceptable ‡ For scoring system see Report Notes
