Milton Malsor Parish Council

Village Park Play Equipment Assessment form

Date of Assessment **26 Sept & 3 October 2011**

PLAY AREA SAFETY INSPECTION REPORT

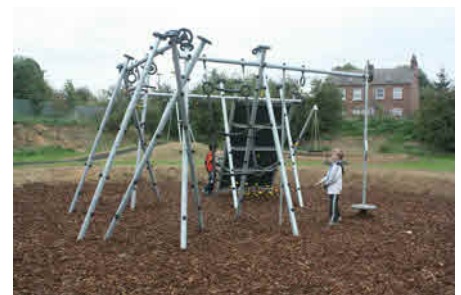
Activzone Unit

General Condition **Satisfactory**

Stability of unit **Satisfactory**

Wear or damage **Satisfactory/Nil**

Metal corrosion **Nil**

Wood condition **Satisfactory**

Rubber & chain parts - **wear/damage Nil**

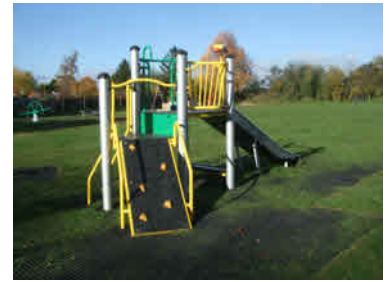
Corrosion; wear; damage **Nil**

Safety surface & other comments **Satisfactory**

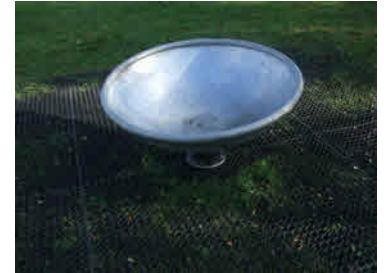
Dish roundabout

Stability **Satisfactory**

Corrosion; wear; damage **Nil**

Safety surface & other comments **Satisfactory**

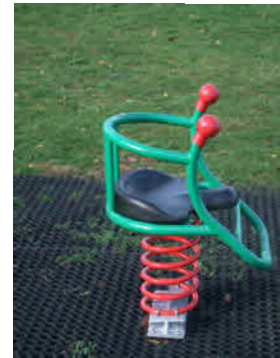
Seat rocker

Stability **Satisfactory**

Corrosion; wear; damage **Nil**

Safety surface & other comments **Satisfactory**

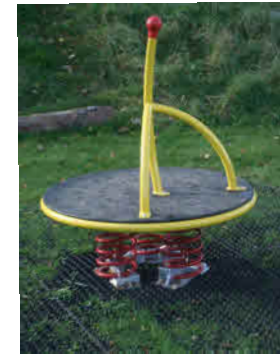
Roundabout Rocker

Stability **Satisfactory**

Corrosion; wear; damage **Nil**

Safety surface & other comments **Satisfactory**

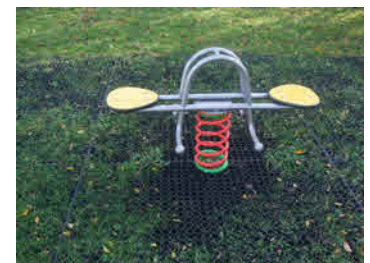
See-saw rocker

Stability **Satisfactory**

Corrosion; wear; damage **Nil**

Safety surface & other comments **Satisfactory**
